RDT&E PROJECT NO. 1M643324D59204

USATECOM PROJECT NO. 7-7-0887-01

INTEGRATED ENGINEERING AND SERVICE TEST OF  
TANK, COLLAPSIBLE, SELF-SUPPORTING,  
5,000-BARREL (TEMPERATE)

FINAL REPORT

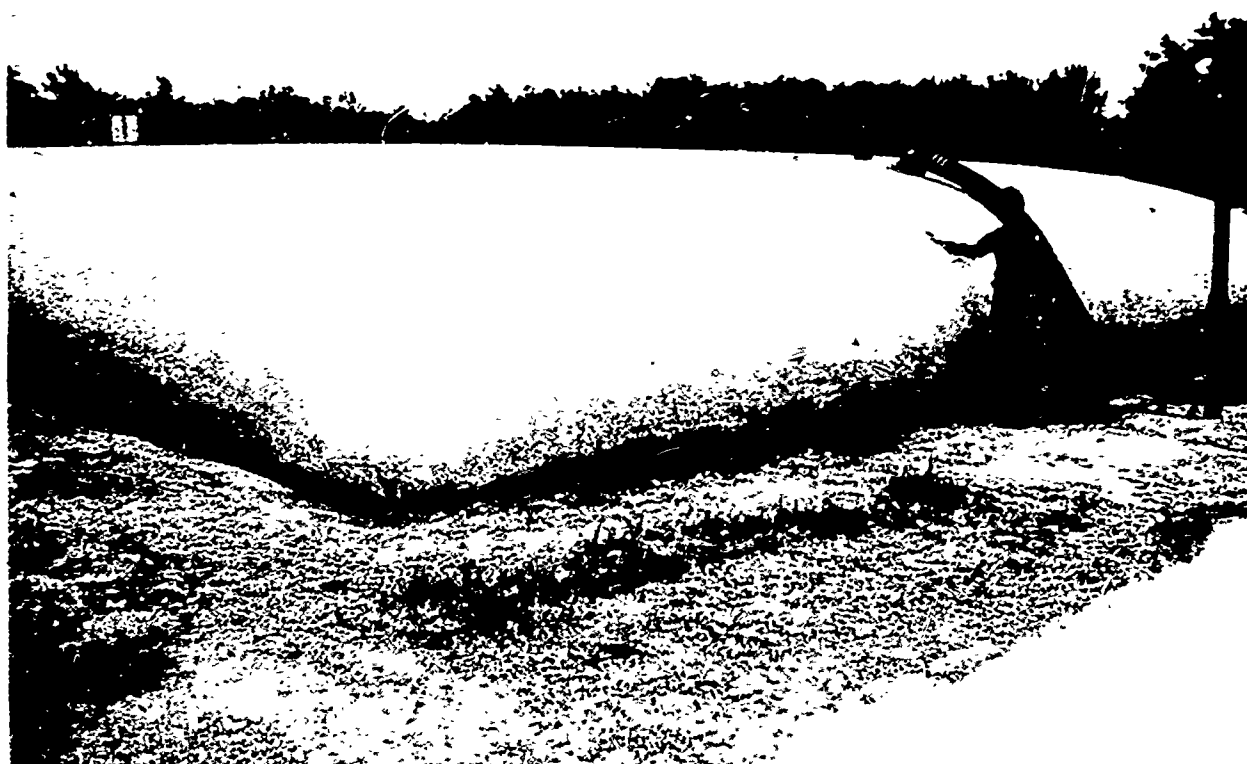
The test item is a 5,000-barrel capacity self-supporting collapsible tank of reinforced synthetic material. Included in the tank are one common inlet-outlet fitting assembly, a bottom drain plug and valve, and a combination overflow-vent fitting assembly. Except for dimensions, capacity, and number of inlet-outlets, the tank is identical in design to the 1250- and 2500-barrel tanks previously tested. The tank is installed by Engineer construction units on a flat rectangular ground surface having less than a 1-percent slope and surrounded by an earthen berm. The tank area when emptied is approximately 48 by 98 feet in size. When installed, the tank is operated by Quartermaster petroleum units. Uncrated, the tank weighs approximately 2,160 pounds. When filled to capacity (Fig. 1), the tank

Figure 1. 5,000-barrel capacity collapsible tank.

extends to a height of about 7 1/2 feet. The manifold assembly of the 5,000-barrel tank is similar to that of the 2500-barrel tank in that it includes ten 20-foot sections of 6-inch diameter steel tubing.

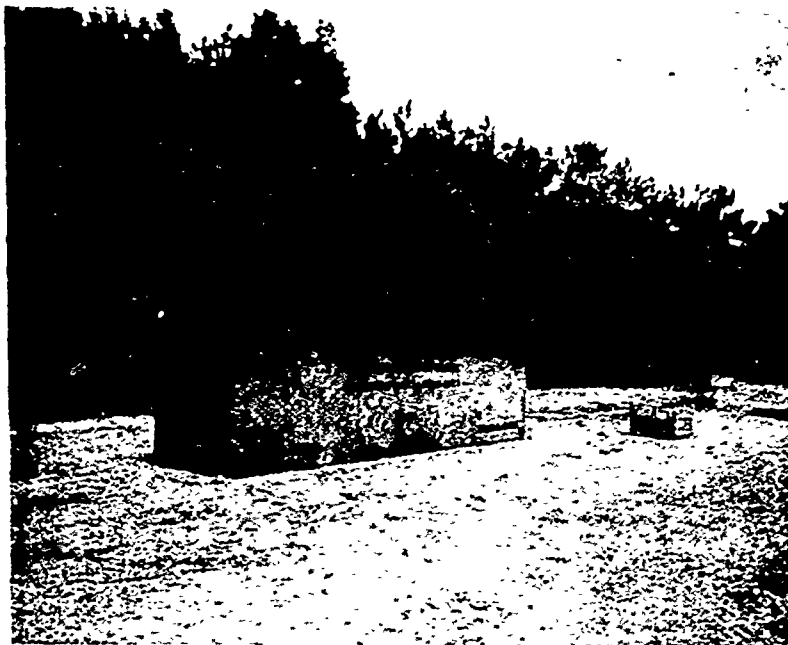
Figure 2. Test item as received in crated condition.

b. Each test item was rolled on a 6-inch steel mandrel mounted in a shipping crate fabricated of 2 x 4, 4 x 4, and 5/8-inch plywood material and reinforced with steel plating and angle iron. The shipping crate dimensions are listed below. Stenciling on the shipping crate was found to be adequate and indicated where and how the crate should be lifted.

c. To open the shipping crate it was necessary to lift the crate top off the framework; however, no method for attaching lifting hooks was evident. Large bolts were driven through the top corners of each crate in order to allow attachment of lifting hooks. The crate top was then removed using a 10,000-pound crane truck after the bolts had been removed

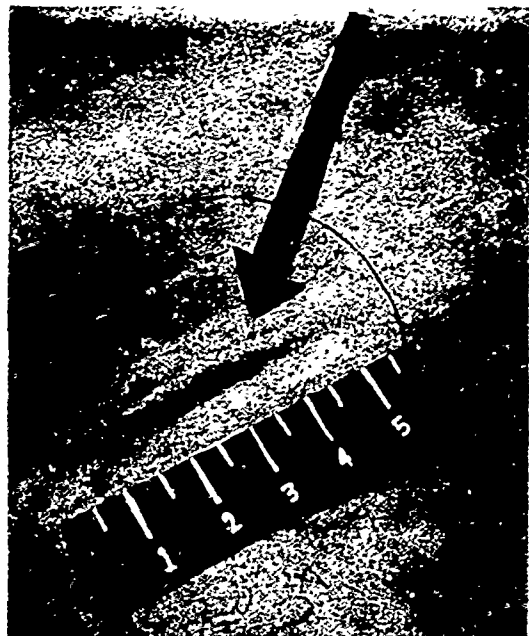
a. Within one week of initiation of fuel cycling operations hundreds of minute wet spots (1/8" to 1/4" diameter) were detected on both test items. Wet spots did not appear to be restricted to seam areas and were evident on the top and sides of both items when in the filled conditions. Inspections showed that after a 60-day period approximately 50 percent of the wet spots disappeared, the remaining 50 percent did not increase noticeably during the remainder of the test period. No evidence of seam slippage was detected during the test; however, this activity received directions to terminate testing operations during the fourteenth month of testing due to seam slippage resulting in catastrophic failure of the test items at other test locations. Inspection of the tank fabric showed deterioration of the outer tank coating to have occurred as evidenced by a softening or chalking effect of the coating especially on Tank No. 1; however, fabric analysis upon completion of testing did not show that this deterioration had reduced the test items' capabilities excessively.

b. Examinations of mechanical repair clamps applied to the test items showed that at least one clamp rusted excessively. It was apparently not fabricated of rustproof materials as were the majority of the clamps which showed no evidence of rust.

Figure 10. Various tank defects (blisters, punctures, and pinhole leaks) detected during testing operations and repaired utilizing mechanical repair clamps.

b. During test operation, mechanized repair clamps were applied to both test items and inspected periodically for evidence of corrosion or deterioration from contact with fuels or water (Fig. 10).

b. All portions of the manifold and appurtenances were found to be sufficiently resistant to the corrosive effects of fuel or water, except the mechanized repair clamps. Only clamps fabricated of rustproof materials should be furnished.

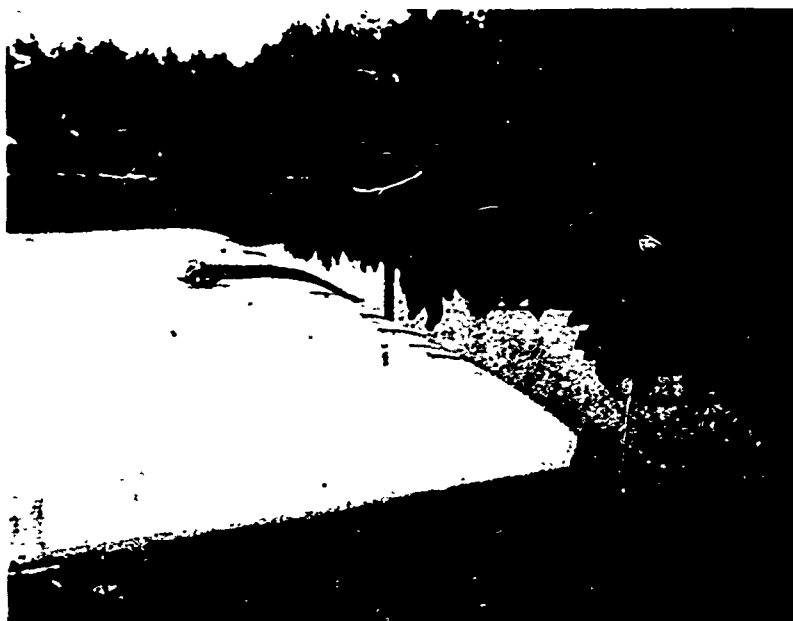
a. The test tanks were found to be capable of safely, durably, and efficiently storing bulk fuel during normal petroleum operations under temperate environmental conditions. Minor problems, however, were experienced in at least one instance with rainfall pooling around the vent pipe when the tank was filled to only a 25-percent capacity (Figs. 17 and 18).

Figure 17. Pooling of water within berm after 1.74-inch rainfall.

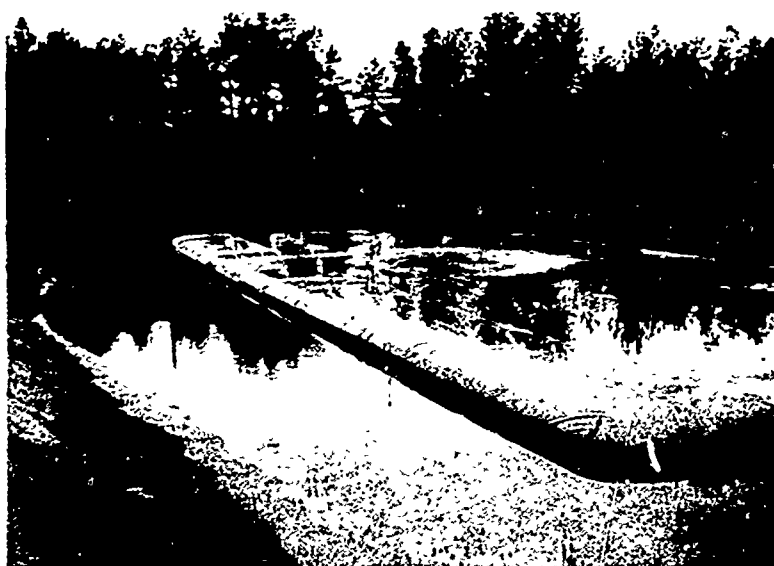
(4) With the tank approximately one-quarter full and after a heavy rainfall, the vent pipe submerged in a pool of water. MOGAS escaped through the vent pipe (deficiency).

Figure 18. Pooling of water on tank surface; vent pipe submerged.

The weight of the water caused the vent pipe to submerge, which allowed fuel to flow out onto the tank surface. Approximately 5,000 gallons of fuel was lost from the test item; however, the fuel was later recovered from within the tank berm. A modification to prevent submersion of the vent pipe due to water pooling was designed but it was not tested due to termination of the test project. The modification consisted of replacing the vent pipe with a 2-inch elbow, 25 feet of 2-inch suction hose with vent pipe cap attached, and a 4 x 4 post of sufficient length to secure the hose end with vent cap well above the top surface of the tank when filled to capacity. This same modification was found very satisfactory when tested on the 10,000-barrel Hasty Storage reservoir.

b. The deficiency and the shortcomings listed in Appendix III be corrected.

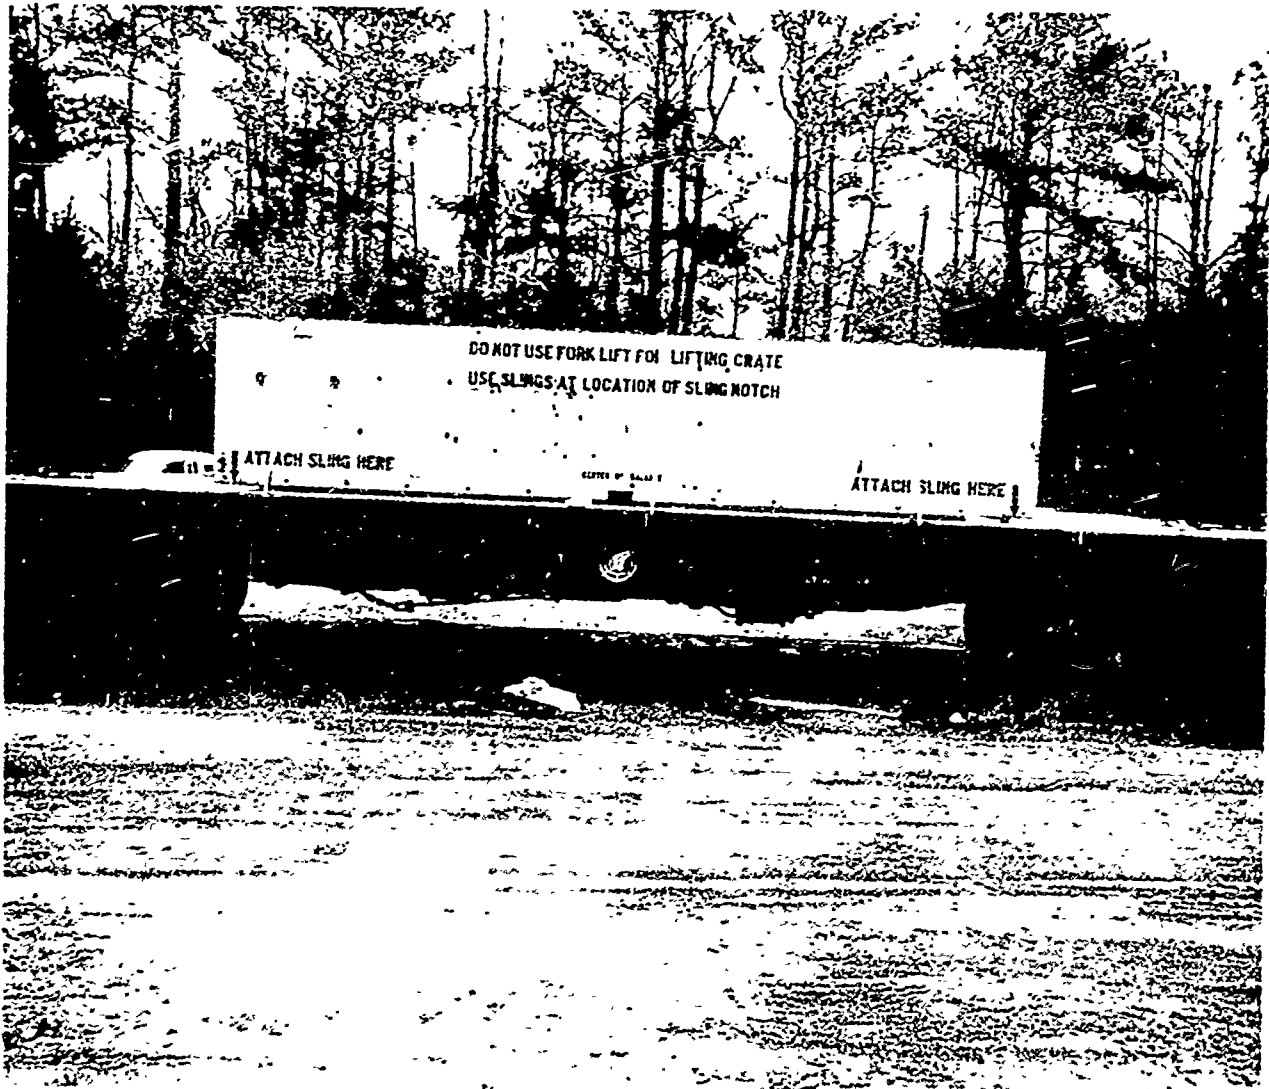
2.7.1.2 Method. The crated item was loaded by a 20-ton mobile crane onto an 80-ton capacity military standard foreign service flatcar equipped with an AAR Coupler on one end and a foreign service screw coupler and buffers on the other end (Fig. 20). Two 5/8-inch wire rope slings were used to lift the crate by passing one under each end of the container. Four antiskid plates were placed under each outside longitudinal skid prior to

Figure 20. Containerized collapsible tank (5,000 barrel) loaded on an 80-ton Foreign Service Railcar prior to rail humping tests.
